WPQR No:
CVT-200620-PQR-
04 (PD)

WELDING PROCEDURE QUALIFICATION RECORD

Reference : BV Rules on Material and Welding for the Classification of Marine Units,
NR216, Ch 5, Sec 4, Approval of Welding Procedures

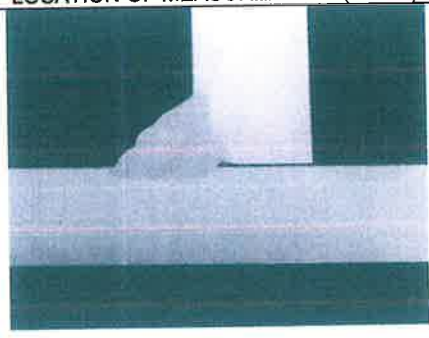
LOCATION OF MEASUREMENTS(sketch)	INDENTATION ROW	RESULTS

A LINE (BASE MTAL)	191-196-194
	A LINE (ITAB)	236-237-(244-239-237)
	A LINE (WELD METAL)	221-221-229
	ALINE (ITAB)	(230-229-232)-186-200
	A LINE (BASE METAL)	201-196-198

Performed by.. DEKRA Kalite Kont. Hiz. A. Ş.
Observations : Lack of fusion have not been observed in weld zone, weld zone is homogeneous

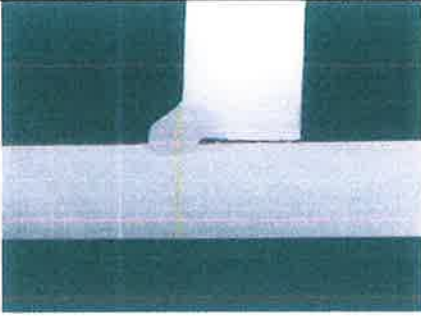
LOCATION OF MEASUREMENTS(sketch)	INDENTATION ROW	RESULTS

A LINE (BASE MTAL)	199-199-201
	A LINE (ITAB)	190-191-(242-246-249)
	A LINE (WELD METAL)	244-241-237
	ALINE (ITAB)	(231-231-223)-185-192
	A LINE (BASE METAL)	190-289-187

Performed by: DEKRA Kalite Kont. Hiz. A. Ş.
 Observations : Lack of fusion have not been observed in weld zone, weld zone is homogeneous

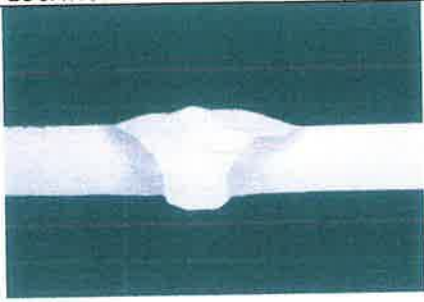
LOCATION OF MEASUREMENTS(sketch)	INDENTATION ROW	RESULTS

A LINE (BASE METAL)	169-165-165
	A LINE (HAZ)	217-268-(228-235-237)
	A LINE (WELD METAL)	208-215-228
	ALINE (HAZ)	(230-227-225)-248-209
	A LINE (BASE METAL)	171-165-168

Performed by.. DEKRA Kalite Kont. Hiz. A. Ş.
 Observations : Lack of fusion have not been observed in weld zone, weld zone is homogeneous

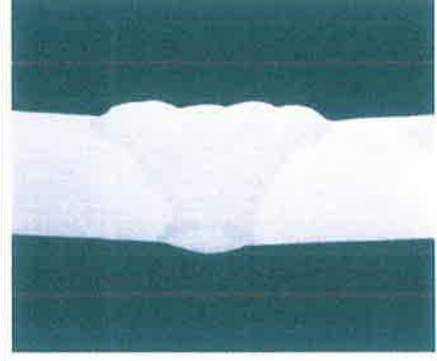
LOCATION OF MEASUREMENTS(sketch)	INDENTATION ROW	RESULTS

A LINE (BASE MTAL)	210-218-212
	A LINE (ITAB)	187-196-(222-225-221)
	A LINE (WELD METAL)	206-229-222
	ALINE (ITAB)	(208-229-234)-186-189
	A LINE (BASE METAL)	199-198-196

Performed by: DEKRA Kalite Kont. Hiz. A. Ş.
Observations : Lack of fusion have not been observed in weld zone, weld zone is homogeneous

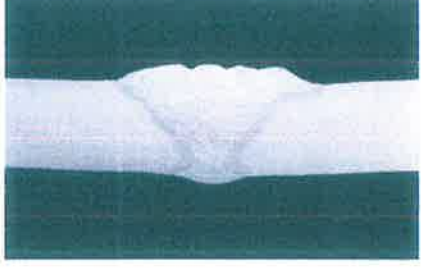
LOCATION OF MEASUREMENTS(sketch)	INDENTATION ROW	RESULTS

A LINE (BASE METAL)	195-296-202
	A LINE (HAZ)	196-195-(237-257-259)
	A LINE (WELD METAL)	237-233-216-(295-250-234)
	A LINE (HAZ)	(205-250-234)-188-199
	A LINE (BASE METAL)	199-207-201

Performed by: DEKRA Kalite Kont. Hiz. A. Ş.
Observations : Lack of fusion have not been observed in weld zone, weld zone is homogeneous.

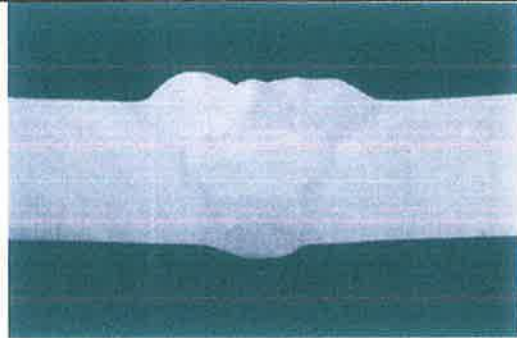
LOCATION OF MEASUREMENTS(sketch)	INDENTATION ROW	RESULTS

A LINE (BASE MTAL)	203-197-198
	A LINE (ITAB)	192-171-(187-181-184)
	A LINE (WELD METAL)	191-202-198
	ALINE (ITAB)	(209-217-217)-193-198
	A LINE (BASE METAL)	200-296-205

Performed by.. DEKRA Kalite Kont. Hiz. A. Ş.
Observations : Lack of fusion have not been observed in weld zone, weld zone is homogeneous
